**ENHANCED PRELIMINARY ASSESSMENT REPORT  
FOR TOOEELE ARMY DEPOT - NORTH AREA  
TOOELE, UTAH**

**AGEISS ENVIRONMENTAL, INC.  
1900 Grant Street, Suite 1130  
Denver, Colorado 80203**

**October 5, 1994**

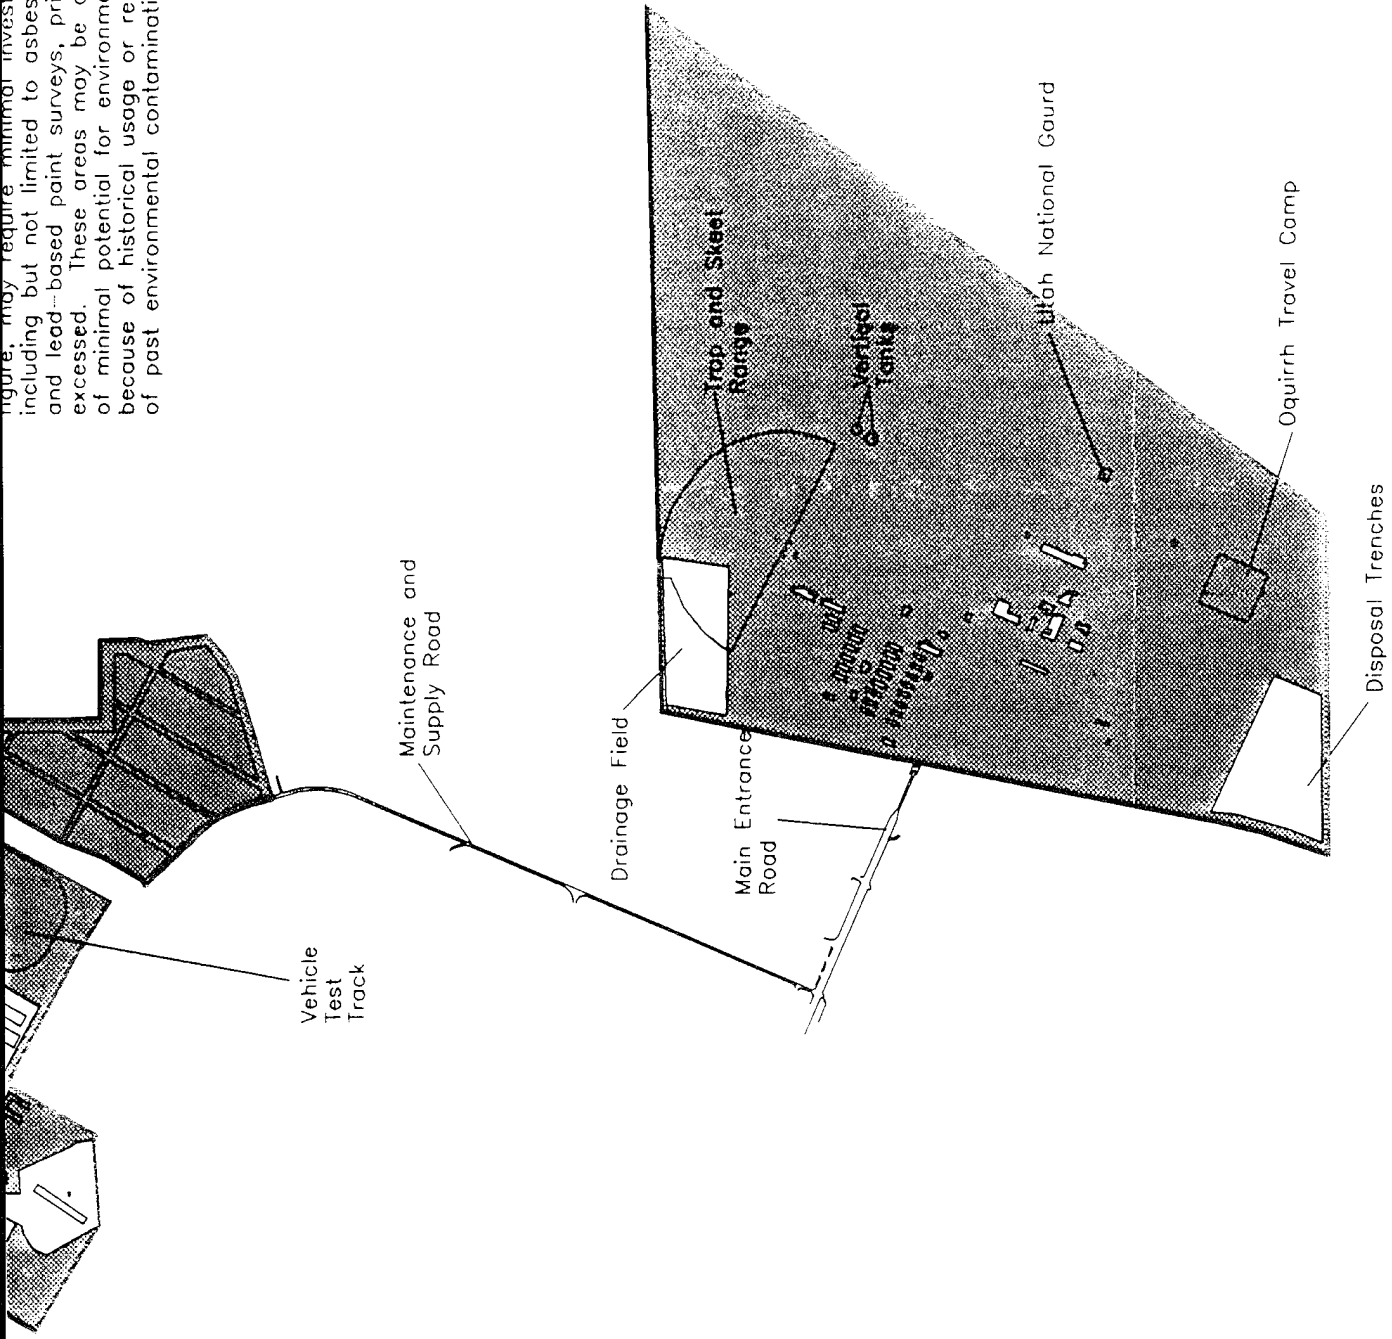
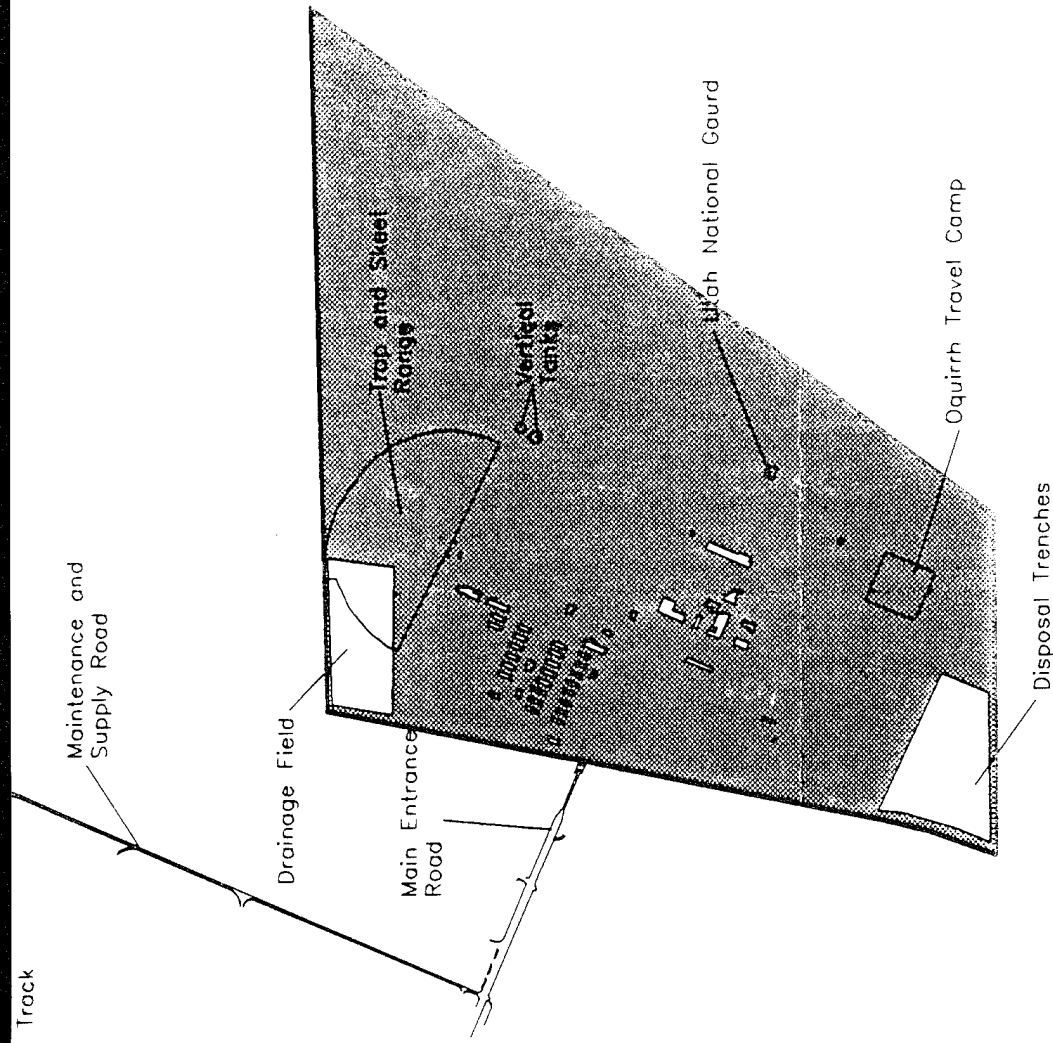
Figure 5-1

These areas with minimal potential for environmental problems are shown in Figure 5-1. It should be noted that even though the above areas may have a minimal potential for environmental problems, the groundwater plume underlies portions of these areas. Also, this report and the conditions represented within are limited to conditions observed and reported at the time of the site visits. It is possible that conditions may have changed since the project site visits or historical practices not uncovered may impact the investigation results.

NOTE: The areas with minimal potential for environmental problems, identified on this figure, may require minimal investigation, including but not limited to asbestos, radon, and lead-based paint surveys, prior to being exceeded. These areas may be considered of minimal potential for environmental impact because of historical usage or remediation of past environmental contamination.

Areas with Minimal Potential for Environmental Problems
